## Technical Memorandum

Re: American Zinc Products (AZP) – Mooresboro, NC – Maintenance Pond Sampling  
Date: September 13, 2021

### ***Maintenance Pond Sub-Liner Hand Auger Sampling***

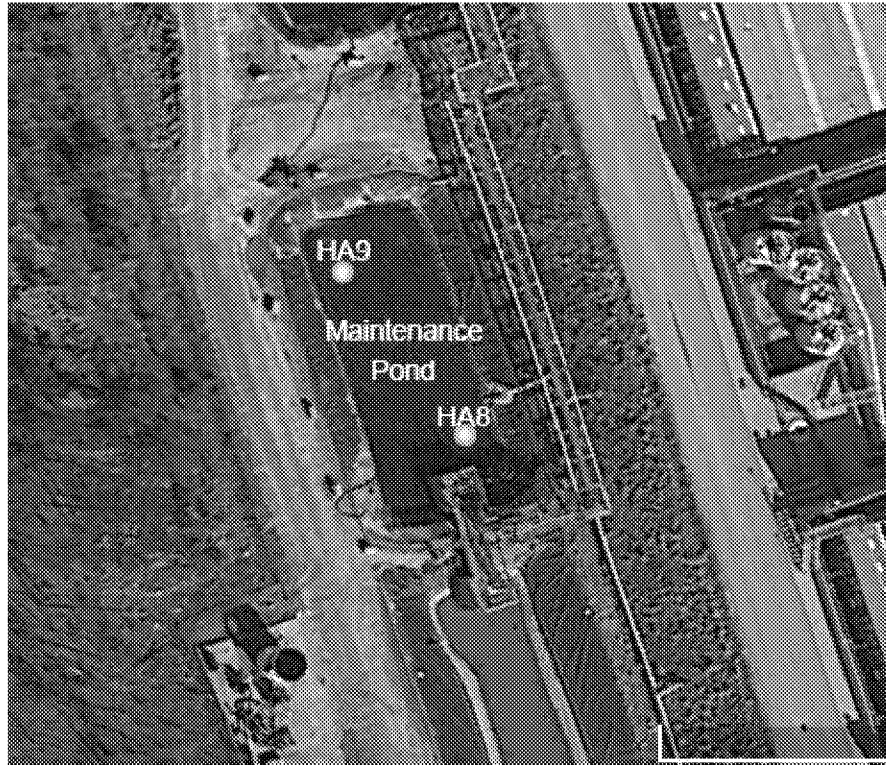
On September 8, 2021 EnSafe mobilized to site to advance two hand auger locations below the liner within the Maintenance Pond. A map of the Maintenance Pond sampling locations can be found below. Location HA8 was advanced in the southeastern portion of the pond near the pump well. Below the liner system there was a layer of sand/gravel approximately 24-inches thick. The sand/gravel layer was moist and had an acidic odor. A shovel was used to remove the sand/gravel layer to expose the underlying soil. Prior to advancing the hand auger within the underlying soil it was noted that liquid was seeping from the sand/gravel layer at about 18-inches below the liner. The liquid contained a brown organic layer which floated on top. A sample was collected, and the pH was measured onsite at 1.33 standard units. The boring was terminated due to the liquid accumulation within the hole. A sample of the sand/gravel bedding material was collected.

The second location (HA9) was advanced in the northwest corner of the pond. The sand/gravel layer was approximately 22-inches thick, had a slight acidic odor but contained no free liquids. A hand auger was used to advance the boring below the sand/gravel layer. Soils consisted of dry silty clay with frequent gravel pieces. The hand auger was advanced to approximately 1-foot below the sand/gravel layer where refusal was met due to large gravel pieces. Three samples were collected at this location: the bedding material, the 0-to-0.5-foot interval, and the 0.5-to-1.0-foot interval.

Sample locations were filled in with the material that was removed, and contractors patched the holes cut in the liners.
